3.0 The Transportation Planning Context

Ramona Road Master Plan

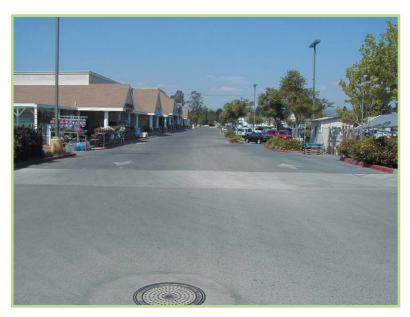
Photo 1: Vermont Street / Pala Street, looking north

Photo 1 displays the Kmart building structure and parking lot situated on two square blocks between Pala Street and Day Street. Access to Kmart is provided via a private driveway utilizing the Vermont Street alignment. The parking lot functions as a through roadway due to a lack of other connections.

Vermont Street is obstructed by the Kmart development at Pala Street, by residential development at 16th Street, and by the police station at Montecito Road. **Photos 1** through **5** illustrate critical gaps in connectivity along Vermont Street.

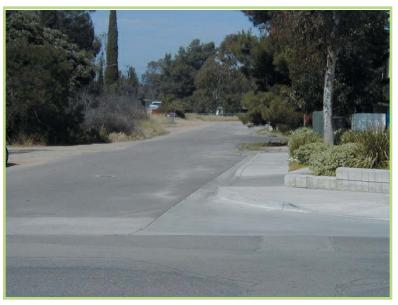
Photo 2: Vermont Street / Day Street, looking north

Photo 2 was taken at the intersection of Day Street and Vermont Street. Vermont Street terminates at an unimproved lot where pedestrian and vehicle dirt trails are currently being utilized by the community.

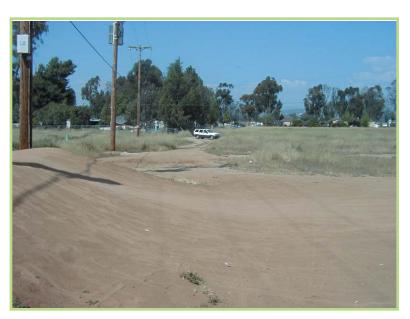
Photo 3:
View from the northern terminus of Vermont Street

Photo 3 shows what would be the continuation of Vermont Street from approximately Day Street to 16th Street. The photo also shows a vehicle traveling along the right-of-way that would be Ramona Street, north of Main Street.

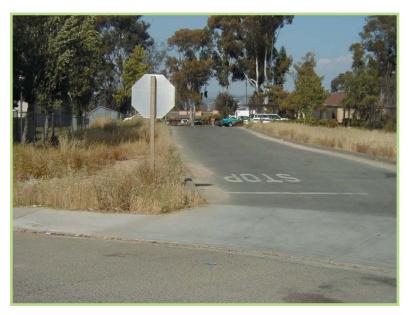
Photo 4: View from the 16th Street cul-de-sac looking north across the Ramona Police Station parking lot

Photo 4 shows potential roadway right-of-way from the 16th Street cul-de-sac to Montecito Road across what would roughly follow the Vermont Street alignment. While the Ramona Police Station parking lot has provided informal access between Montecito Road and 16th Street, a gate has recently been installed, therefore limiting access.

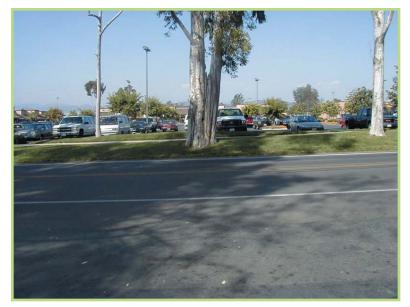
Photo 5:
Albertson's shopping center, looking north from
Montecito Road

Photo 5 shows the Albertson's Shopping Center which was constructed in the right-of-way where B Street would connect between Montecito Road and 14th Street.

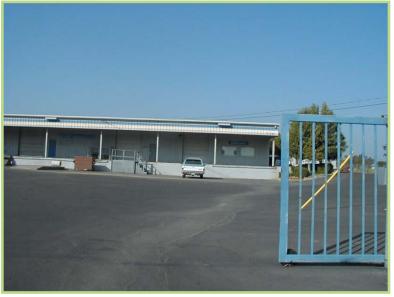
Photo 6: Looking north from "B Street" and 14th Street

Photo 6 shows an industrial development that was constructed in the right-of-way where A Street would connect between 14th Street and 13th Street.

Land uses obstructing potential extensions of B Street are older and less intense than those obstructing Vermont Street. B Street connectivity is typically interrupted by older industrial developments and rural uses. **Photos 6** and **7** show some of these major obstructions.

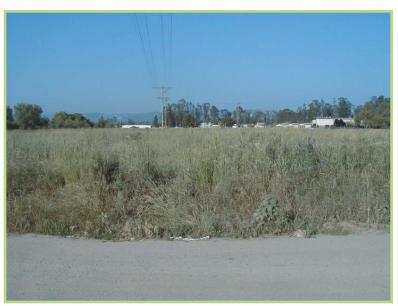
Photo 7: View from 13th Street and "B Street", looking north

Photo 7 shows open space and rural uses between 13th Street and 12th Street generally following the B Street alignment. The bull ring grounds are located at the far side of the open space area shown in Photo 7, at the intersection of B Street and 12th Street.

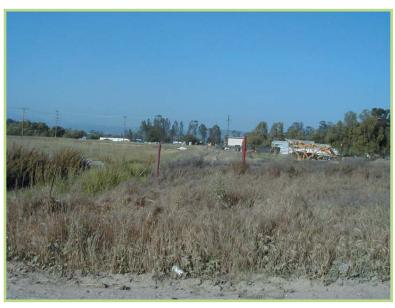
Photo 10: View looking north from 13th Street and "A Street"

Photo 10 shows unimproved open space along what would be the A Street extension between 11th Street and 13th Street.

Further extensions of A Street are currently obstructed by a small pond at 11th Street and residential/commercial uses between 12th Street and 14th Street. **Photos 8** through **11** display these obstructions, from north to south.

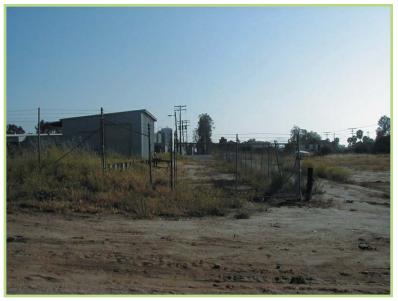
Photo 11:
View looking south from 13th Street and "A Street"

Photo 11 shows the general area where A Street would connect from 13th Street to 14th Street, with underutilized industrial uses on the parcel.

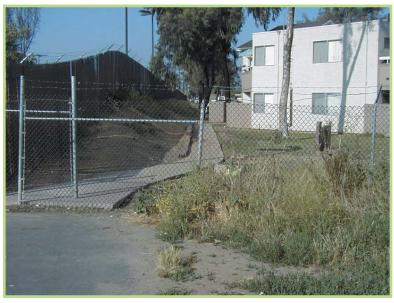
Photo 12: E. Montecito Road and "D Street", looking north between the Post Office and an apartment complex

Photo 12 shows the general location where D Street would connect between E. Montecito Road and 14th Street. This important connection was lost with the development of the Post Office and an apartment complex.

Further extensions of D Street are obstructed by residential developments at 14th Street, by the Post Office at E. Montecito Road, and by several commercial and medical buildings between E. Montecito Road and 16th Street. **Photos 12** through **15** show some of the obstructions to extending in D Street.

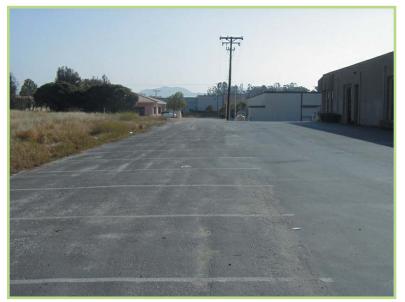
Photo 13: E. Montecito Road and "D Street", looking south behind a medical/office complex

Photo 13 shows the location where D Street would connect between E. Montecito Road and 16th Street. This location is currently a parking lot for medical/office buildings and is utilized as a thoroughfare.

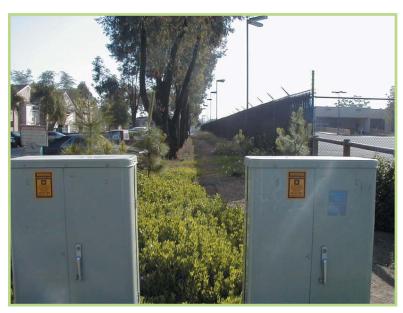
Photo 14: View from D Street and 14th Street, looking south

Photo 14 is another view of the D Street alignment between E. Montecito Road and 14th Street, looking south from 14th Street.

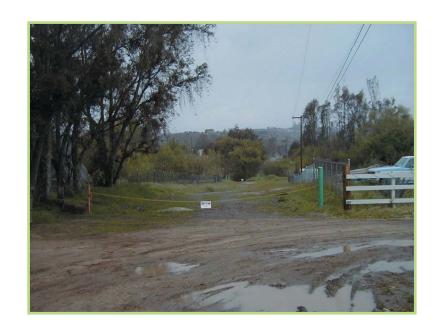
Photo 15: View from Hunter Street, looking west to Montecito Road

The Santa Maria Creek, which runs roughly parallel to Main Street near the Town Center area, has also inhibited the ability to implement key roadway connections. Hunter Street extends from Main Street through to Cedar Road, and has been identified as a candidate for improvement across the creek.

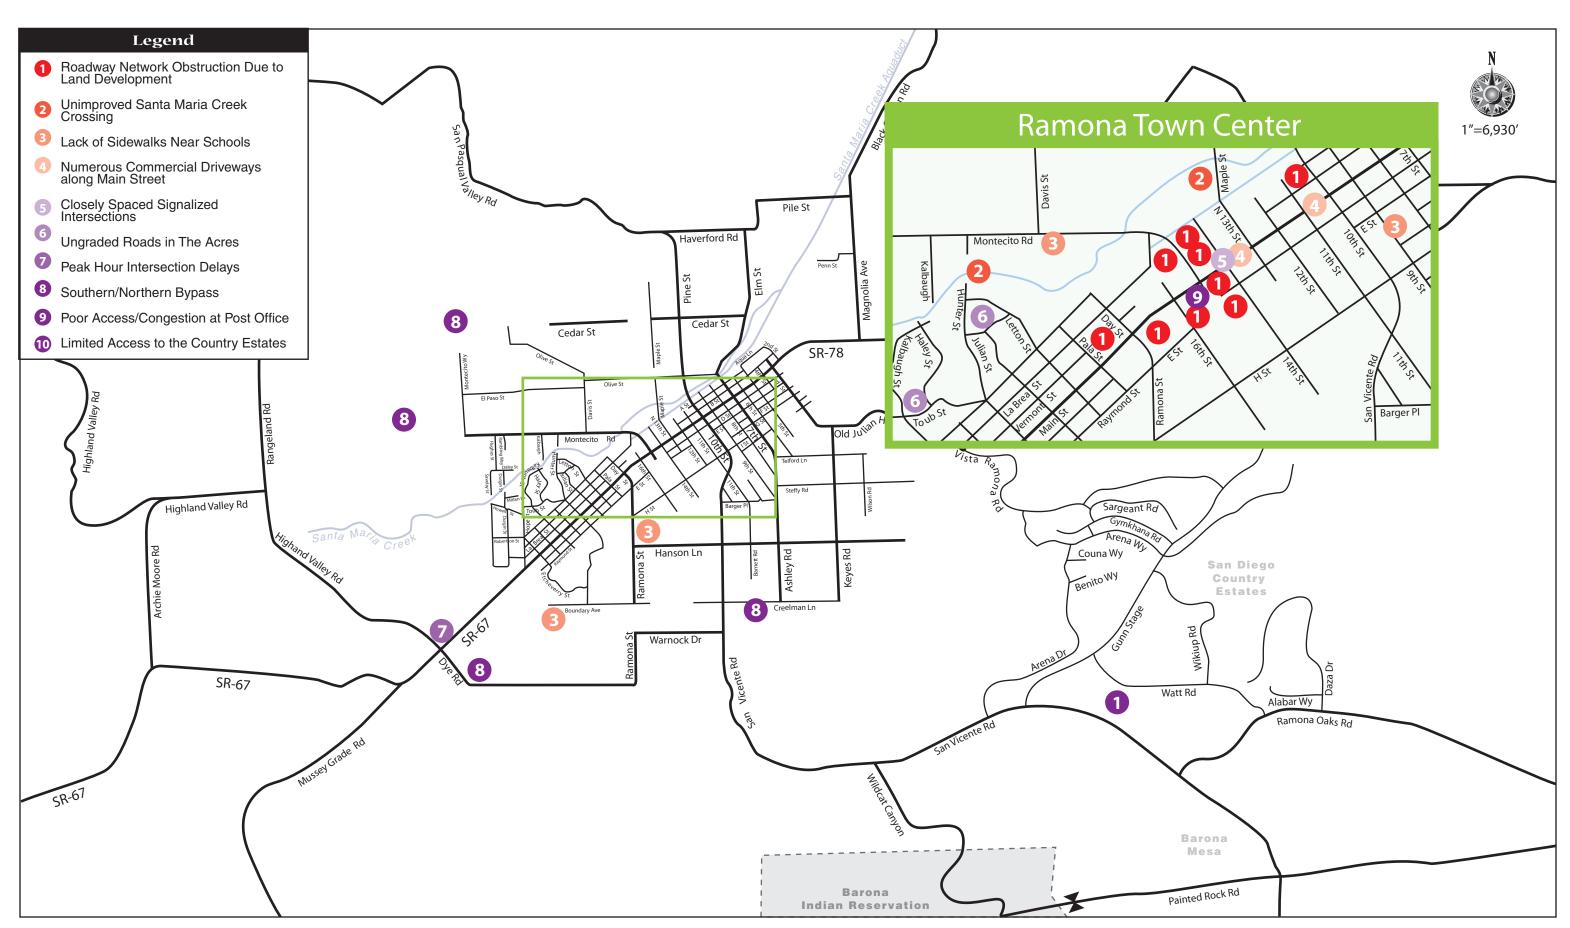
Figure 3-4 summarizes the various transportation issues and their generalized location in the Community of Ramona. Each of the identified transportation deficiencies are addressed in the Plan Elements with specific goals, policies and programs to be considered for implementation by the County of San Diego. ❖
